## EXPLODING CELL PHONE

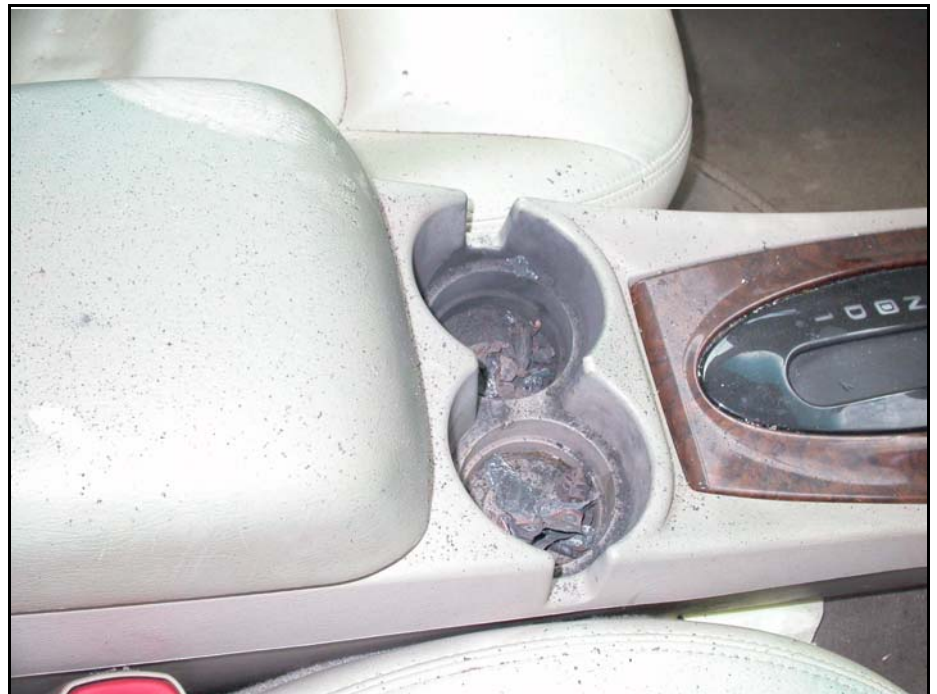
Figure 1

The burn patterns in the passenger compartment were peculiar. A localized fire had burned near the base of the passenger's side front seat, in a spot where no powered devices or electrical wiring had been present. Otherwise, the cup holders on the console between the front seats (where the cell phone had reportedly been placed) were full of metal fragments (see Figure 1). The cup holder on

It did not take long to arrive at the conclusion that the cell phone battery had exploded into numerous hot metallic fragments, one of which was sizeable enough to ignite the carpeting on the floor of the

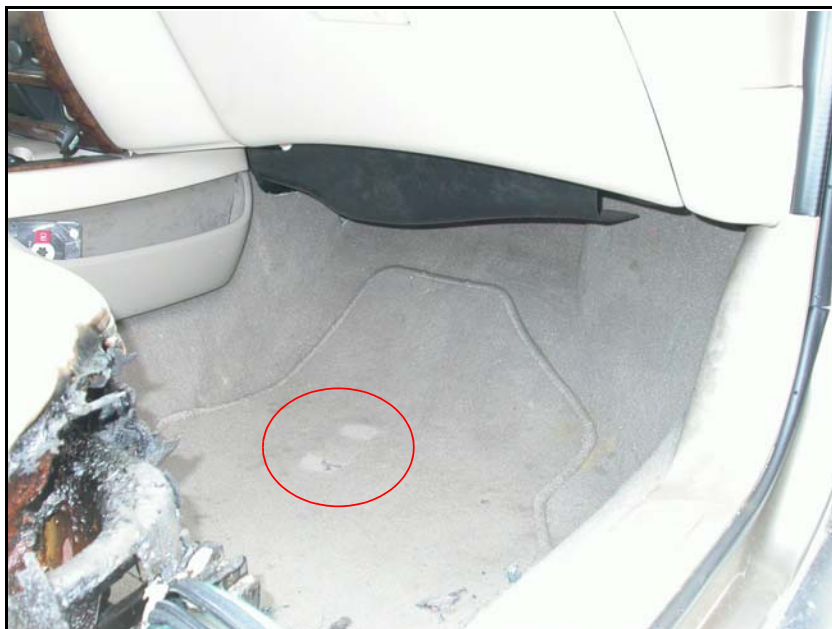
Figure 2

the driver's side was more heavily soot covered than that on the passenger's side. The cell phone, missing its back cover and its battery, was found on the carpet beneath the dashboard, with a "shadow" of the back of the phone (minus its back cover) left behind on the carpet (see Figure 2). Thin metal fragments, accompanied by black dust, were found all around the front seat (see Figure 3). In one case, a scorch mark similar in shape to the fragment was found directly under it (see Figure 4). Figure 5 shows the cell phone, its back cover (which was later found near the console) and the cell phone battery charger. The battery was nowhere to be found.
